GENERAL EQUIPMENT INSPECTION DETAILS

2013 KOMATSU 930e UNIT 246

Ad Number # 8220 Year: 2013 Location: Naveda Manufacturer: Komatsu Equipment Model: 930e VIN: KMTHD038N61A31557 Engine: Cummins Horsepower: Transmission: NOT APPLICABLE Mileage: 17378 Hours: ECM Mileage:0 ECM Hours: Running: Inspected By:

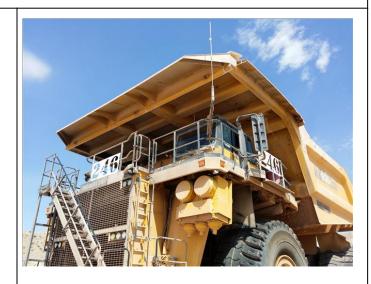
UNIT WILL NEED A NEW ENGINE. COMPLETE FAILURE. Some minor pieces were removed and will have to be replaced on the drive axle. Parts are the electric brake control valves as told to us.
