GENERAL EQUIPMENT INSPECTION DETAILS

2013 KOMATSU 930e UNIT 246

Ad Number # 8220 Year: 2013 Location: Naveda Manufacturer: Komatsu Equipment Model: 930e VIN: KMTHD038N61A31557 Engine: Cummins Horsepower: Transmission: NOT APPLICABLE Mileage: 17378 Hours: ECM Mileage:0 ECM Hours: Running: Inspected By:

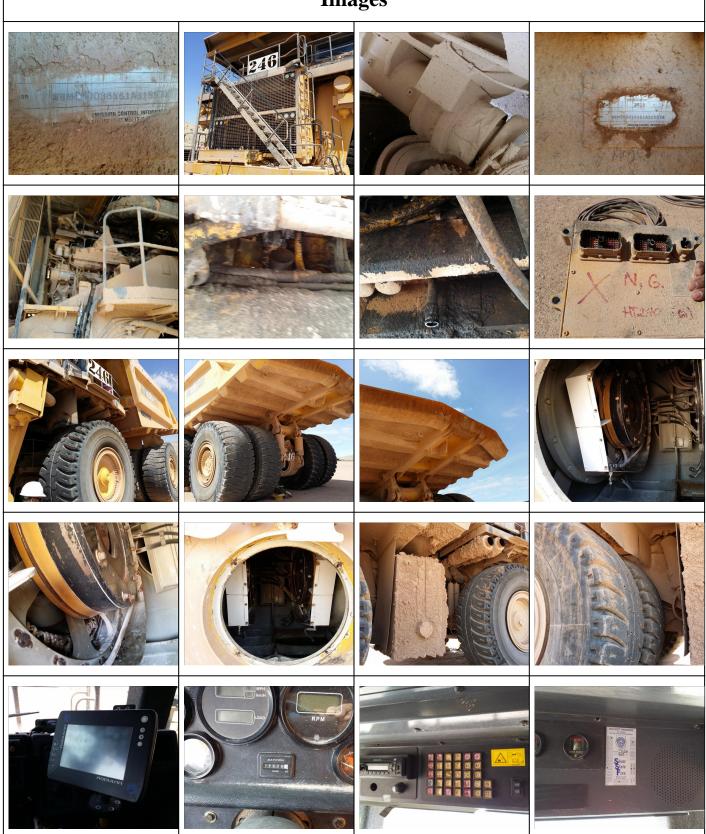
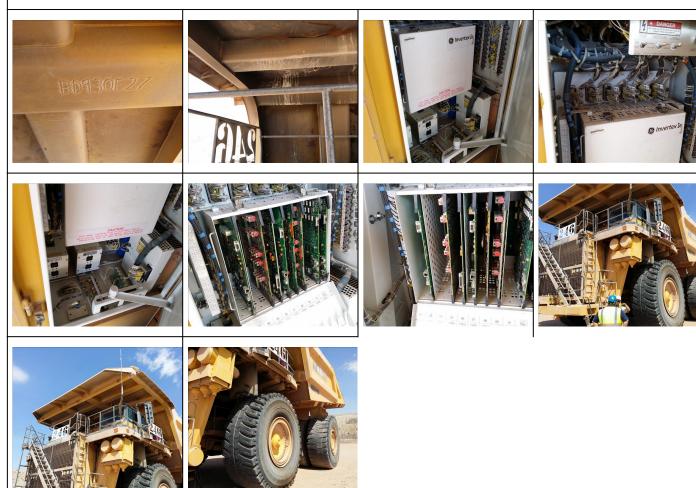
UNIT WILL NEED A NEW ENGINE. COMPLETE FAILURE. Some minor pieces were removed and will have to be replaced on the drive axle. Parts are the electric brake control valves as told to us.
